**Tier 1 Report of
Facility Condition Assessment**

**For
City of Los Altos
Hal Brady Hall
97 Hillview Avenue
Los Altos,
94022-3740**

Date of Report: June 10, 2016

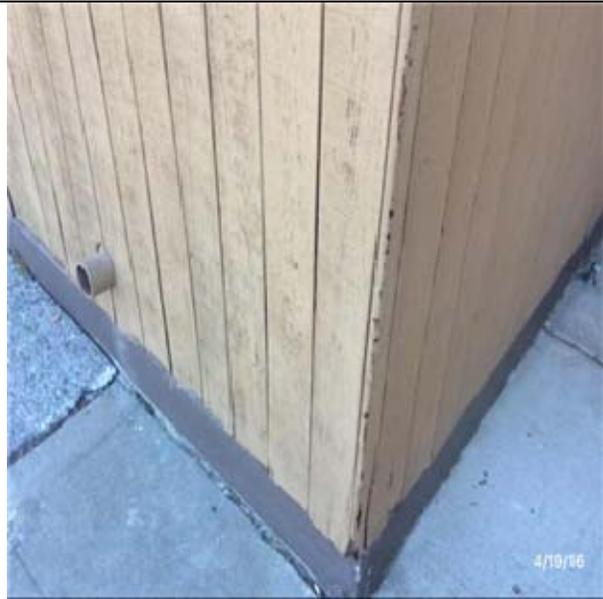
The exterior wall construction was observed to be in poor condition. The wood siding has not been painted for a considerable time and is in a poor condition and in urgent need of repair and or replacement. It was reported that maintenance has been deferred due to the presence of lead based paint.

B2011 Exterior Wall Construction:- View of Wood Clapboard Siding

In addition we also recommend repainting of the surface of the wood siding at the end of the term in the study period to maintain the appearance of the building and also the wood itself.

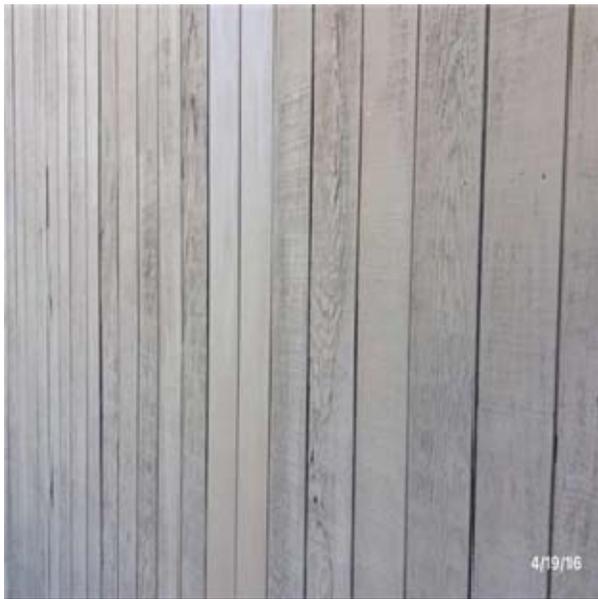
B2011 Exterior Wall Construction:- View of Wood Clapboard Siding

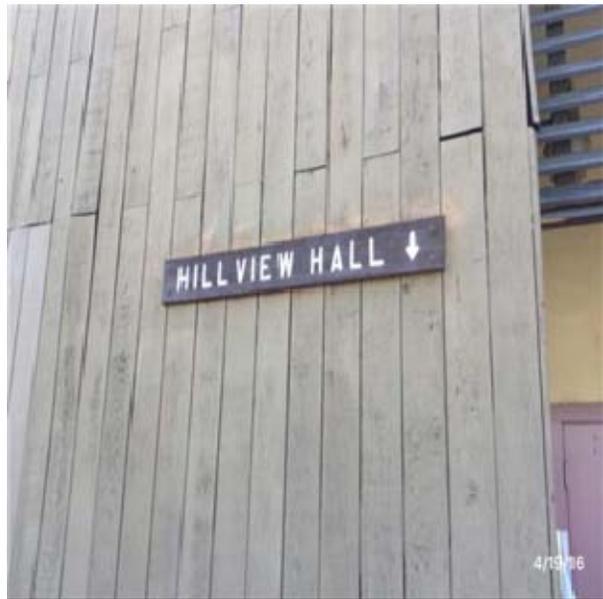
B2011 Exterior Wall Construction:- View of Wood Clapboard Siding

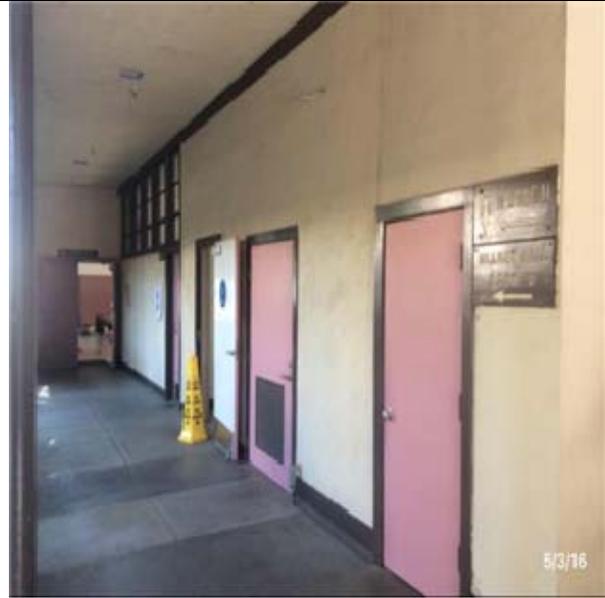
The exterior soffits appeared to be in fair condition; therefore we do not anticipate any actions during the study period. We do however recommend repainting of these surfaces later in the study period to maintain the appearance of the building and also protect the asset.

B2016 Exterior Soffits:- View of Exterior Soffits

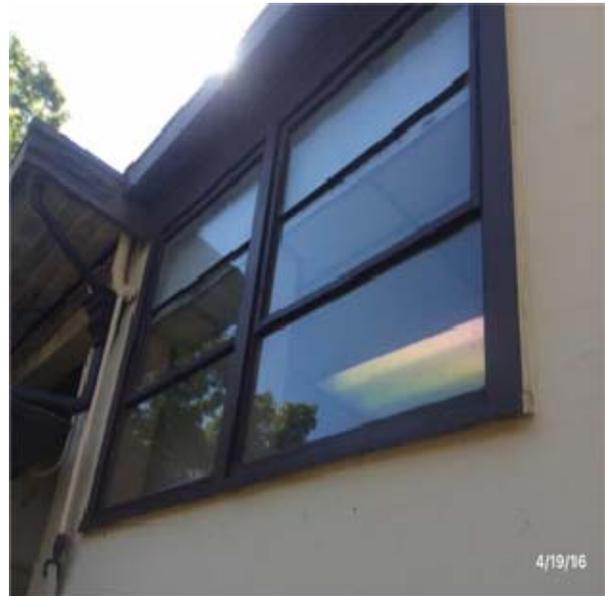
The window systems appeared to be in fair condition. We noted no deterioration of frame and/or glass which would require any actions during the study period. The wood frame windows at the building were observed to be in poor condition. We have assumed the windows to be original based on the current condition, which would put the windows well past their useful life. Glass has been replaced recently due to difficulty of operation, and the frames showed signs of corrosion. We recommend replacing the window immediately in order to maintain the appearance and security of the building as well as prevent water penetration.

B2021 Windows:- View of Wood Window Units - Fixed or Single Hung

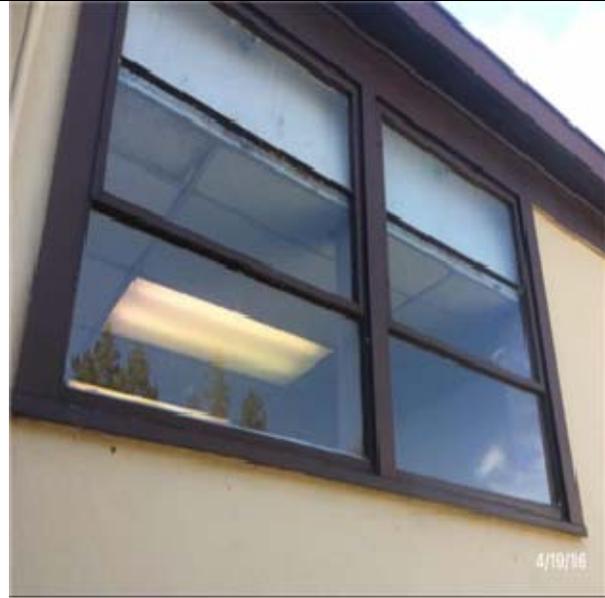
B2021 Windows:- View of Wood Window Units - Fixed or Single Hung

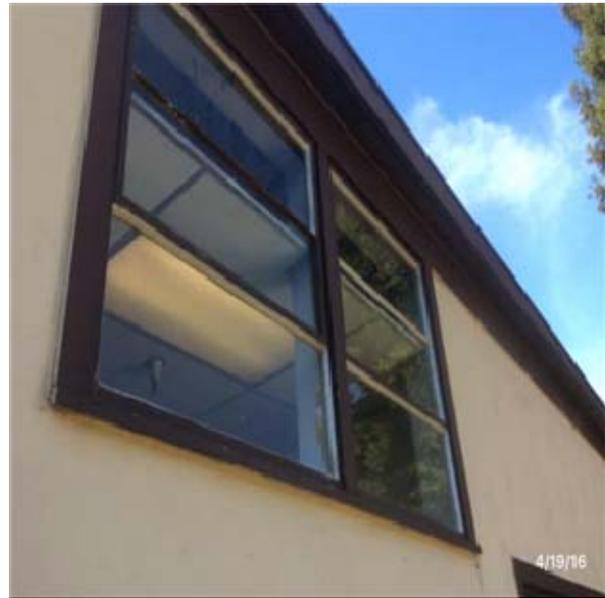
B2021 Windows:- View of Wood Window Units - Fixed or Single Hung

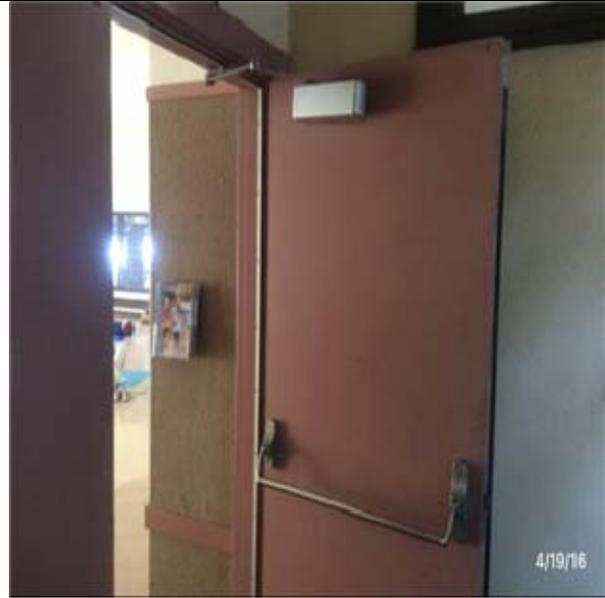
All the double wood doors at the building were observed to be in poor condition. We have assumed these double doors and a single door to the fire riser to be part of the 1985 refurbishment, which would put the doors at the end of their useful life. Wood doors typically have a EUL of 30 years, therefore we recommend replacement of these doors later in the study period.

B2032 Solid Exterior Doors:- View of Double Solid Core Wood Doors

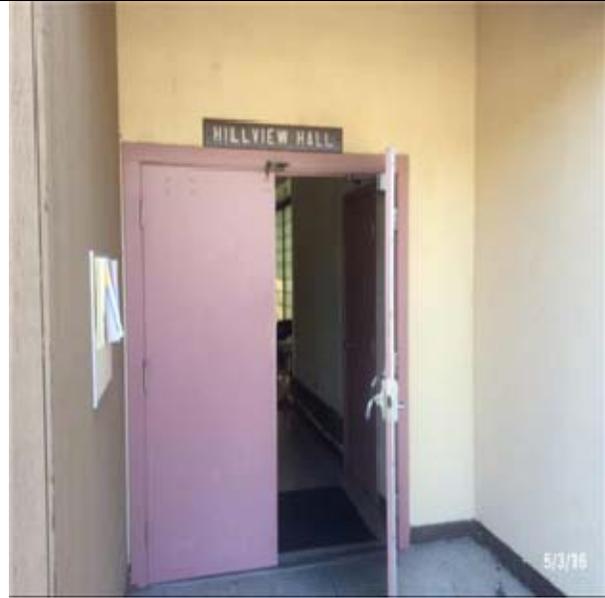
B2032 Solid Exterior Doors:- View of Double Solid Core Wood Doors

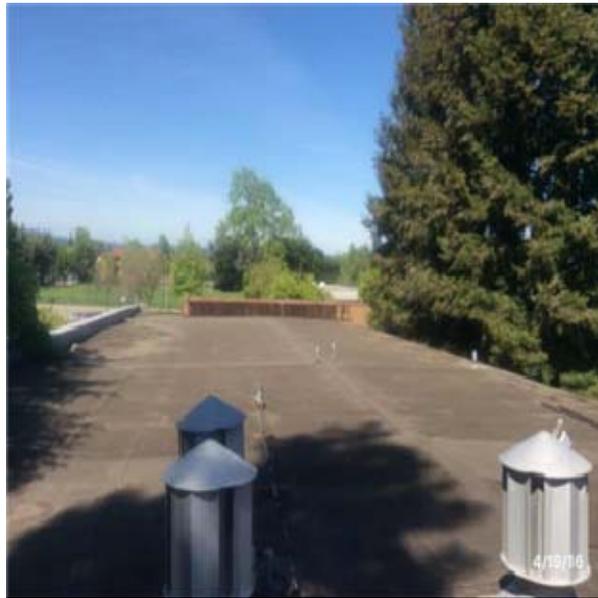
The roof construction and deck are not visible due to their location, however, there are signs of roof deflection and ponding was observed on the roof. The maintenance personnel reported that the roof deck is defective in places and not safe to walk on. We recommend the roof deck be inspected and if necessary replaced at the same time as the BUR roof covering is replaced.

B3011 Roof Finishes:- View of BUR (Built-up Roofing) Covering
